**125<sup>TH</sup> STREET FIREHOUSE RESTORATION  
NEW YORK, NY**

**GEOTECHNICAL INVESTIGATION  
REPORT**

**MAY 2011**

**HALCROW, INC.**

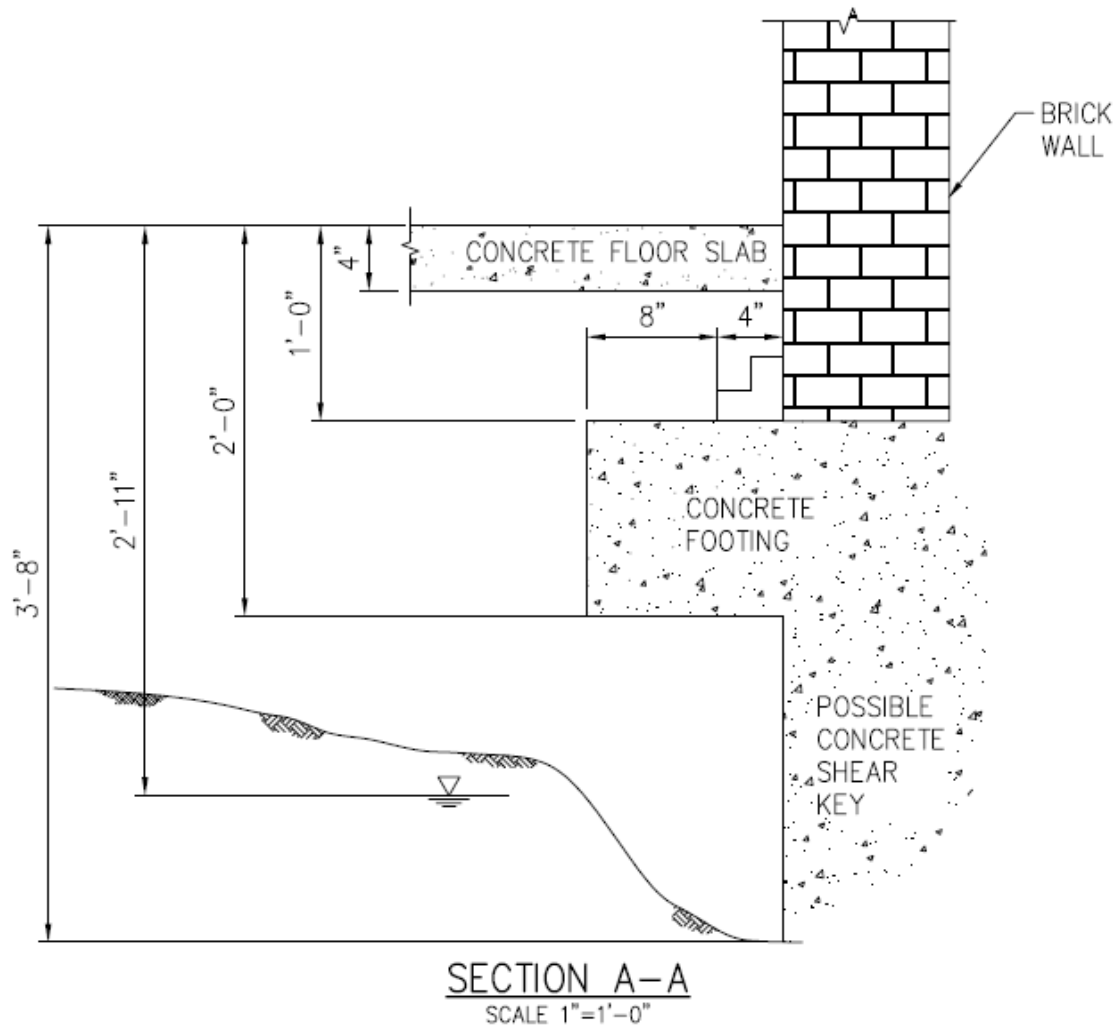
**Figure 6-1 Exposed Conditions at Test Pit TP-1**

At Test Pit TP-1 a 1 ft thick concrete strip footing that projects 1 ft from the face of the wall was encountered at a depth of 1 ft below the top of the floor slab. Further, another foundation element, possibly a shear key, with its face lining up with the face of the brick wall was also encountered. The bottom of this lower foundation element appears to be at 3 ft 8 in. depth, which was the depth excavated within the test pit. In order to reach the bottom edge of the footing, a sump pump had to be used since it was below the water table. The width of the lower foundation element, the possible shear key, could not be ascertained due to steady and rapid seepage into the excavation.

Figure 6-1 provides the exposed foundation details revealed by Test Pit TP-1. For location of Test Pit TP-1, see Figure 4-1.

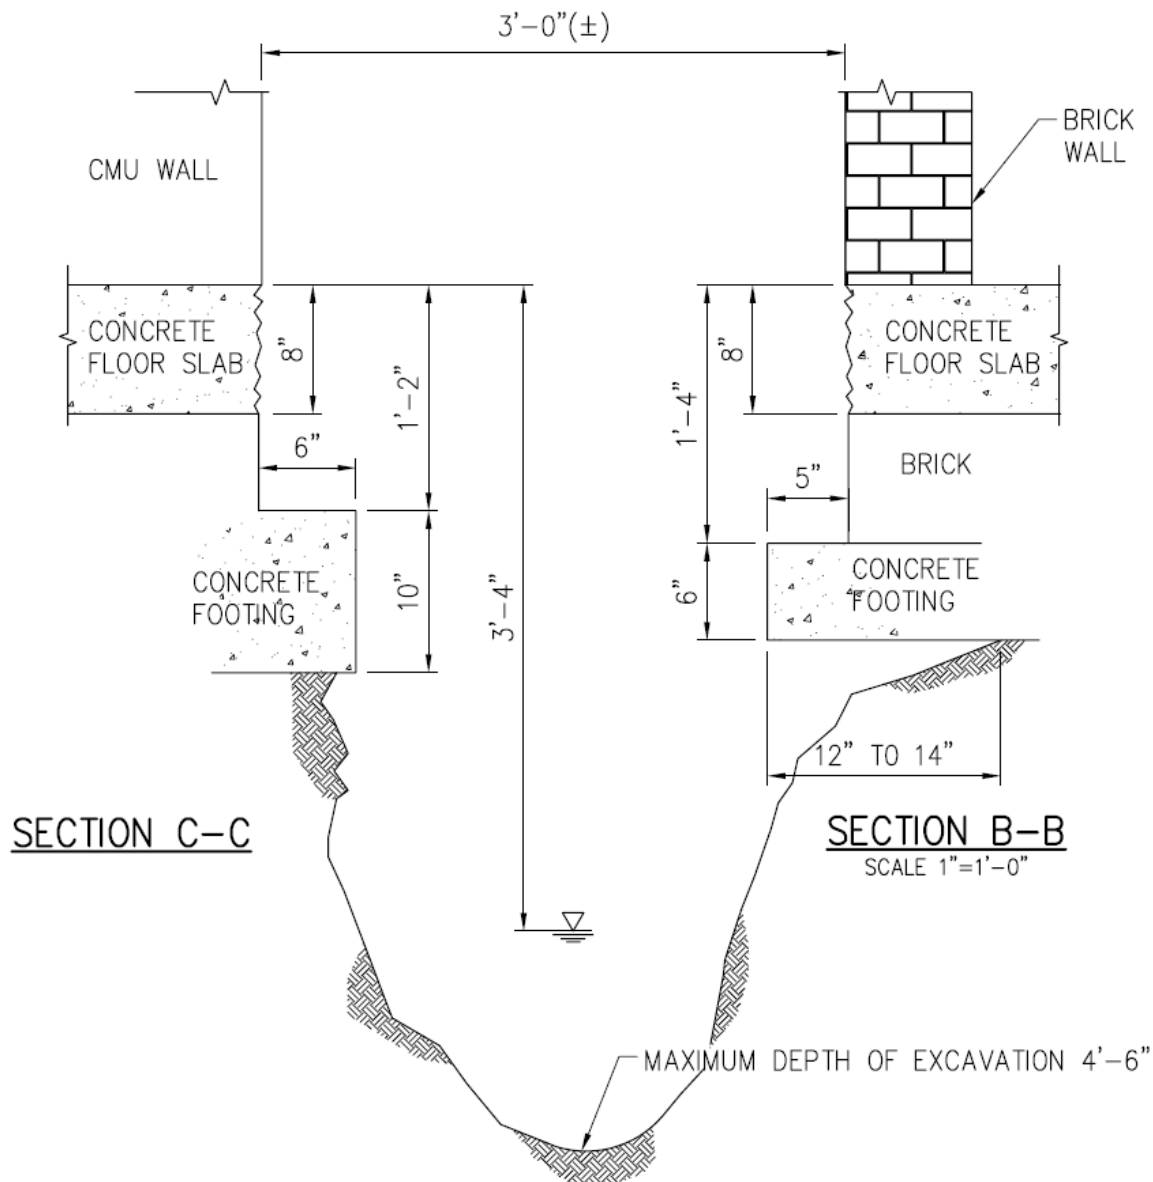
**Figure 6-2 Exposed Conditions at Test Pit TP-2**

Test Pit TP-2 was excavated to expose the existing foundations supporting the exterior brick wall and the interior CMU wall, both located within the vicinity of this test pit. Two concrete strip footings were revealed during this excavation. The excavation

(i) Concrete Footing Supporting the Brick Wall at the North End of the Basement

The top of this footing was found at the north face of the test pit at a depth of 16 in. below the top of the basement floor slab. This footing, which is about 6 in. thick, projects 5 in. from the face of the wall. This footing was locally undermined over a length of about 2 ft along the wall, by as much as 12 in. to 14 in. laterally under the footing. The width of the footing however, could not be confirmed. No other supporting foundation element below the described footing was discovered. Section B-B in Figure 6-2 depicts the findings.

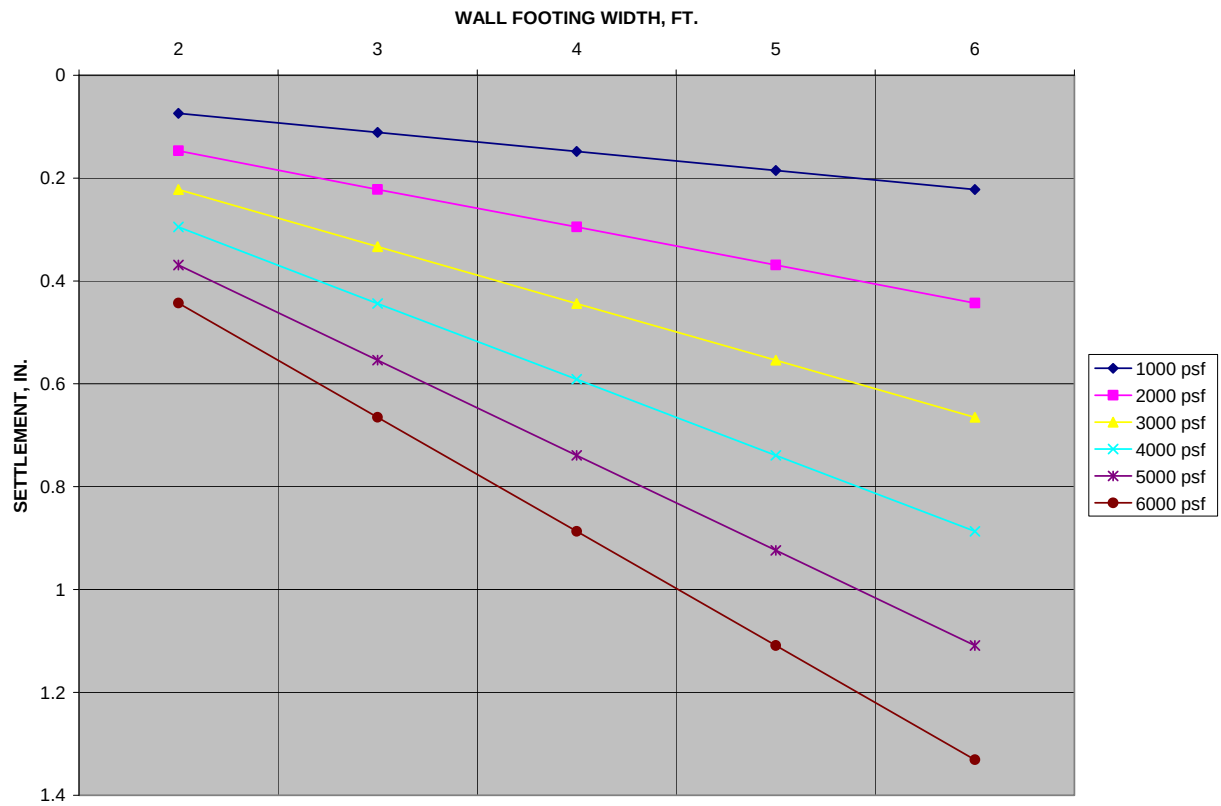
**Figure 9-1 Estimated Wall Footing Settlement**

The estimated settlements for wall footings ranging from 2 ft in width to 6 ft in width are presented in Figure 9-1. Note that in the figure the estimated settlements are plotted for bearing pressures of 1,000 psf, 2,000 psf, 3,000 psf, 4,000 psf, 5,000 psf, and 6,000 psf.

Since the subsurface conditions consist mostly of granular soils, the estimated settlements provided in Figures 9-1 and 9-2 are elastic in nature and expected to occur instantaneously as foundation load is applied. Figures 9-1 and 9-2 can be used to estimate the settlement that has occurred previously due to construction of the original structure, as a result of the currently applied foundation pressures, and also, to determine the magnitude of the additional settlements that can be expected as a result of the additional foundation pressure due to the proposed renovation. If this evaluation indicates that expected total and differential settlements are greater than 1 in. and ½ in., respectively, then consideration needs to be given to increasing the size of current foundations.

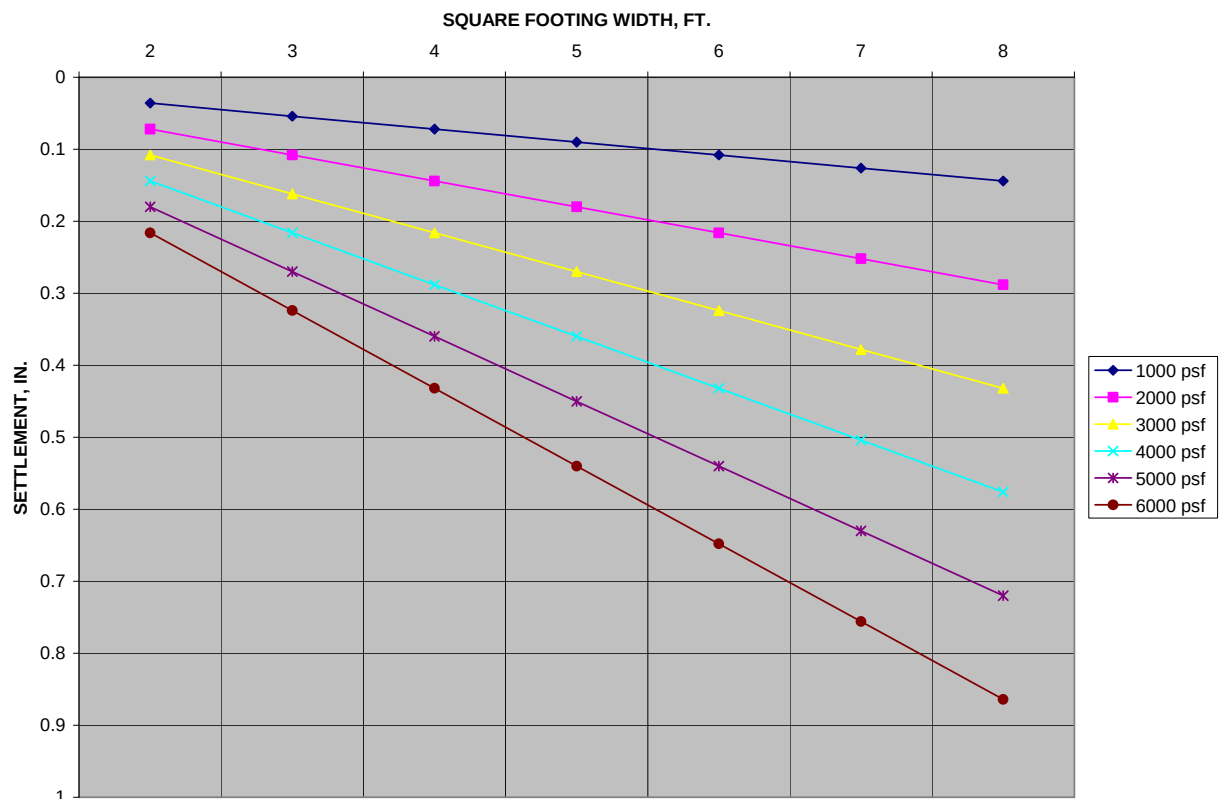
**Figure 9-2 Estimated Square Footing Settlement**

The estimated settlements for square footings ranging from 2 ft. in width to 8 ft. in width are presented in Figure 9-2. Note that in the figure the estimated settlements are plotted for bearing pressures of 1,000 psf, 2,000 psf, 3,000 psf, 4,000 psf, 5,000 psf, and 6,000 psf.

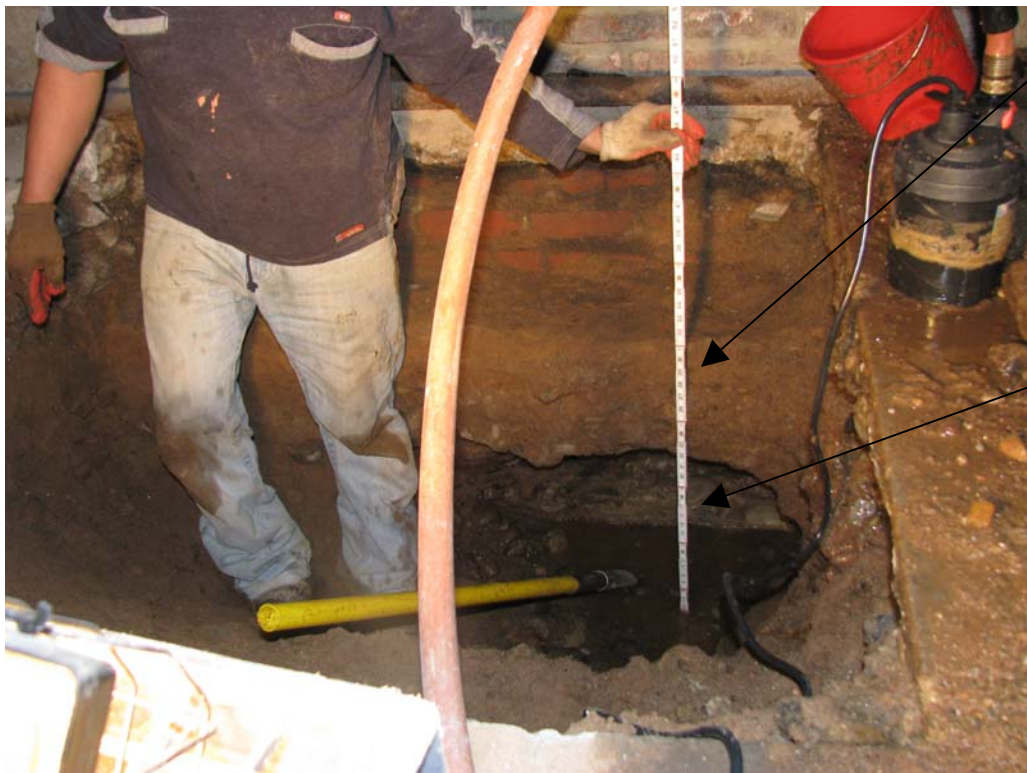
**Photo 1**  
**TP-1**

Concrete strip footing 12 in thick with its base at a depth of 2 ft below the top of the basement floor. The footing projects 12 in from the face of the brick wall above.

Concrete foundation element, possibly a shear key, located below the above described footing with its face roughly in line with the basement brick wall. The bottom of this is about 3 ft-8 in below the top of basement floor.

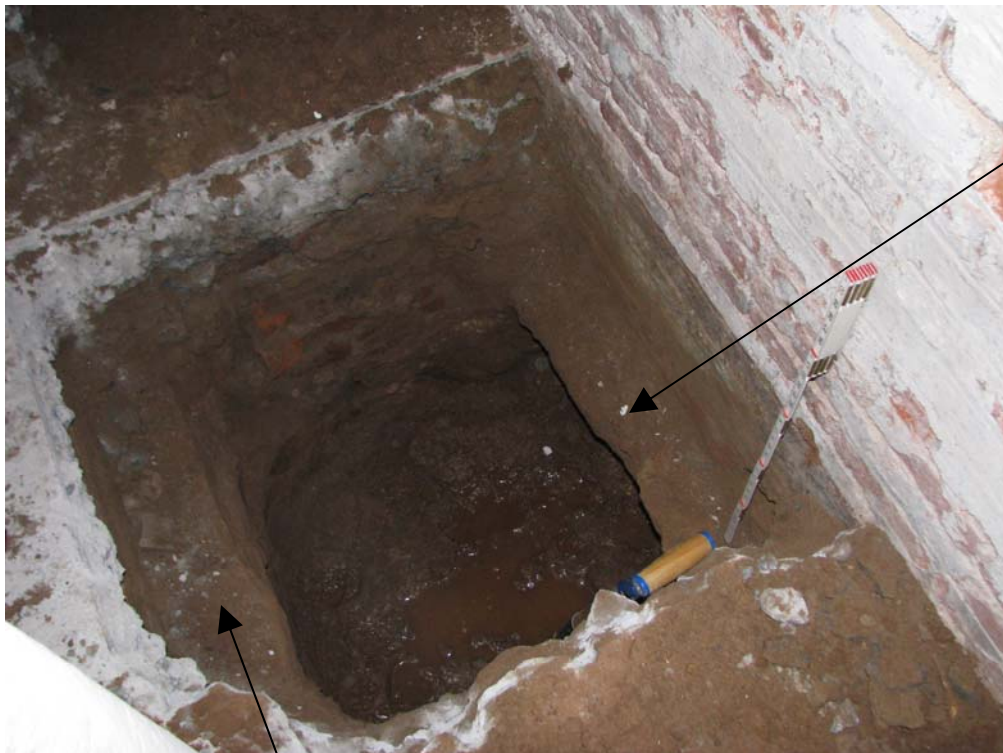
Concrete footing 6 in thick with its base at a depth of 1 ft-10 in below the top of the basement floor. The footing projects 5 in from the face of the brick wall.

Concrete footing 10 in thick with its base at a depth of 2 ft below the top of the basement floor. The footing projects 6 in from the face of CMU wall.
