## SOIL PERCOLATION TEST

DRYWELL PERCOLATION TEST

Drywell Percolation Test per Local law  
103/89 & RS-16.

LOCATION: 20 ELVIRA COURT

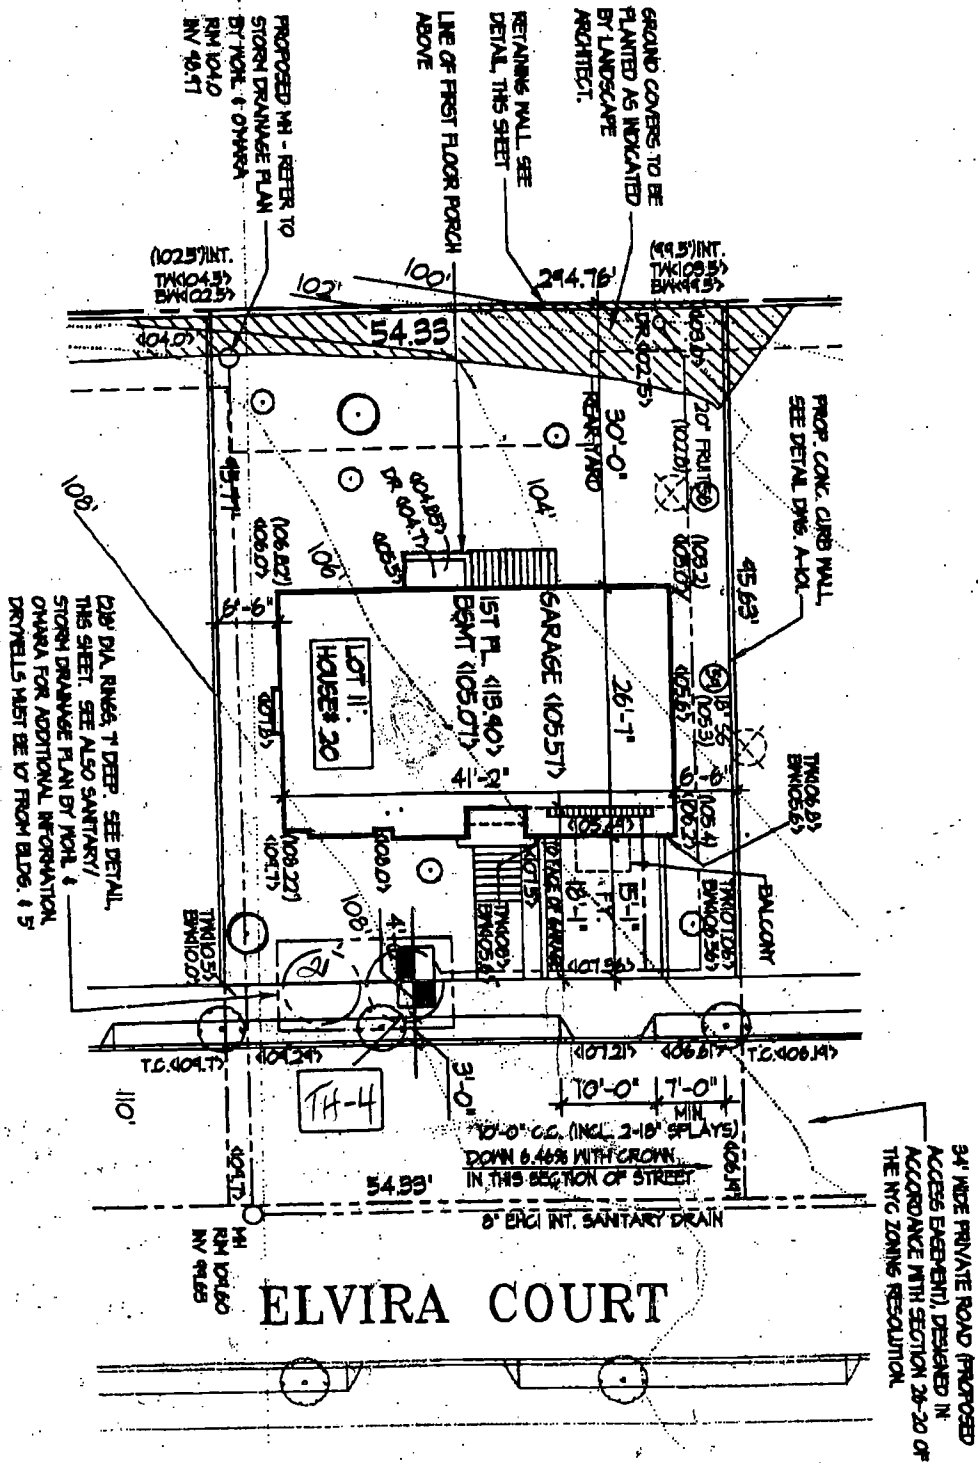
**Drawing #** 1 **of** 2

**Plan Showing Location Of:**

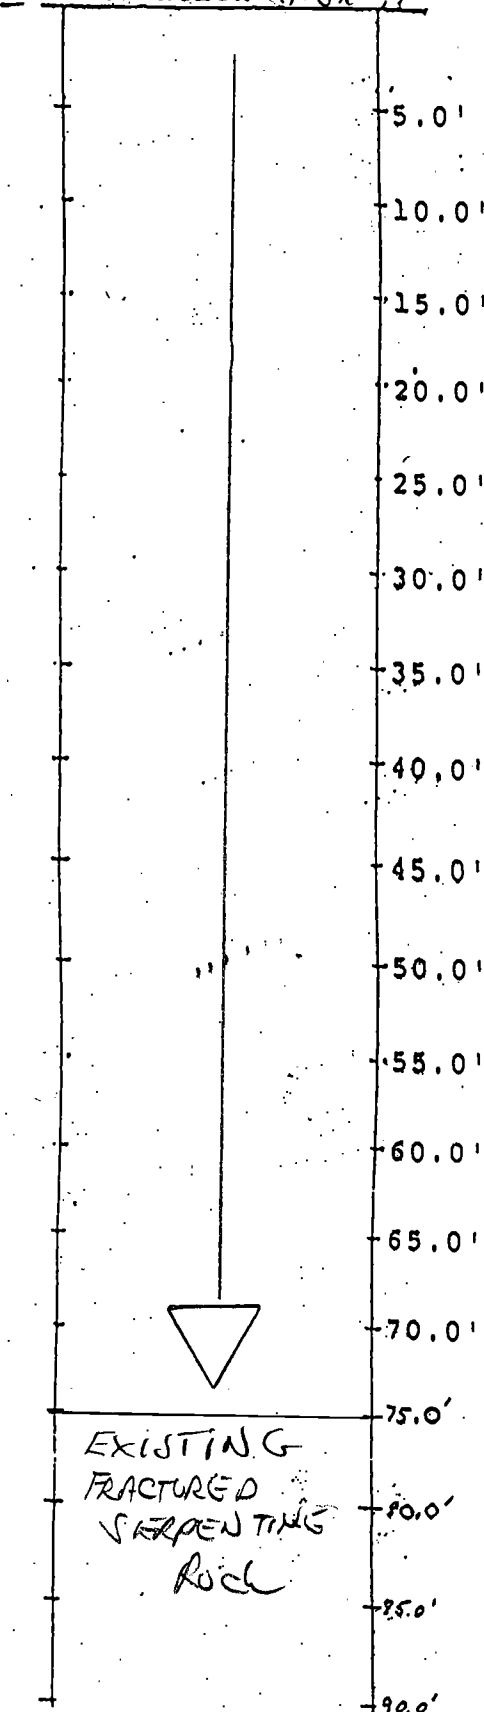
Section Through Test Hole Vertical  
Scale: 1" = 10.00'

6" Ø TEST HOLE FILLED  
WITH WATER  
COMPLIED WITH RS16, P113

Test Hole 6" Ø Dug to a Depth of  
75 feet. Hole filled with WATER  
RS16, P113

No Ground Water Encountered

System Saturated with Water. Steady  
Percolation Rate Achieved After  
Saturation is: 2.27 Gallons per min.
