Plan Showing Location Of:

Soil Percolation  
TEST

# DRYWELL PERCOLATION TEST

Drywell Percolation Test per Local law  
103/89 & RS-16.

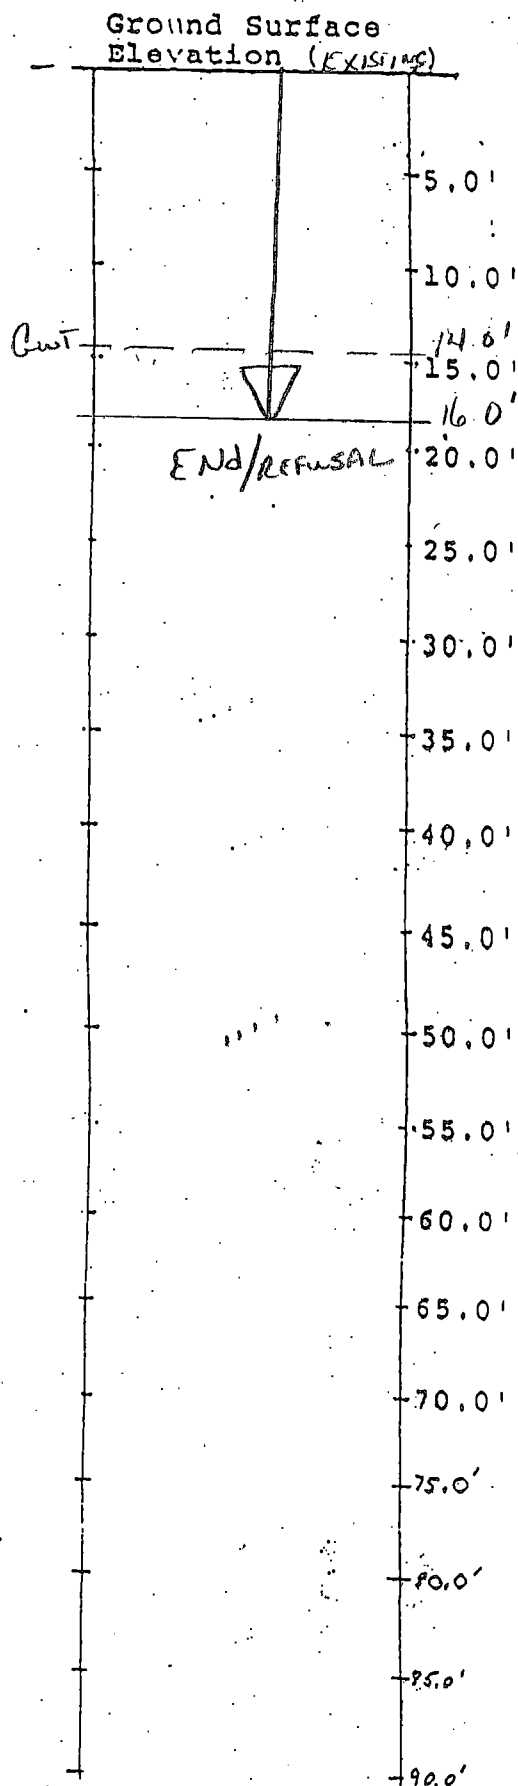
TEST HOLE # 1

Test Hole 6"Ø Dug to a Depth of  
16 feet. Hole filled with WATER  
RS16, P113

Ground Water Encountered @ 14 FT

System Saturated with Water. Steady  
Percolation Rate Achieved After  
Saturation is: 1.98 Gallons per min.

6"Ø TEST HOLE FILLED  
WITH WATER  
COMPLIED WITH RS16, P113

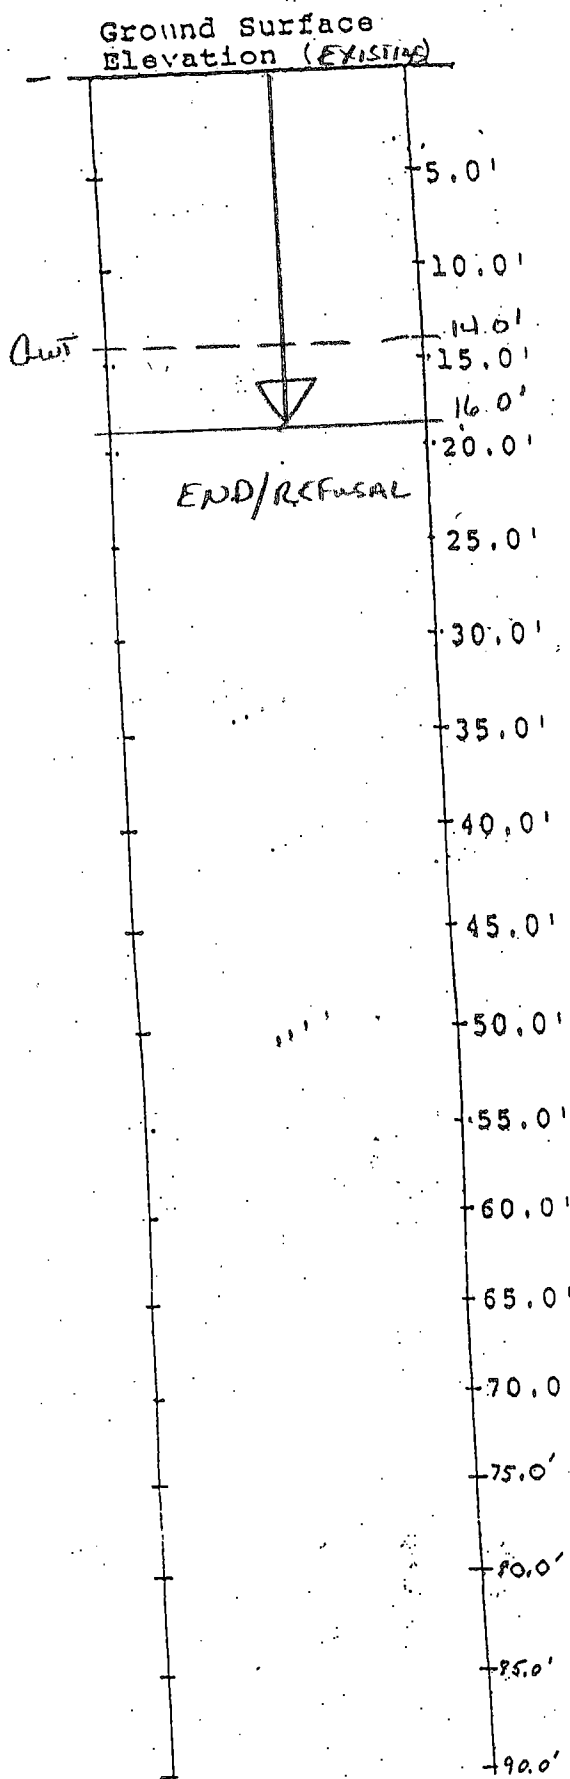
TEST HOLE # 2

Test Hole 6"Ø Dug to a Depth of 16 Feet. Hole filled with WATER  
RS/6, P113

Ground Water Encountered @ 14 FT

System Saturated with Water. Steady Percolation Rate Achieved After Saturation is: 1.95 Gallons per min.

6"Ø TEST HOLE FILLED

WITH WATER  
COMPLIED WITH RS16, P.113

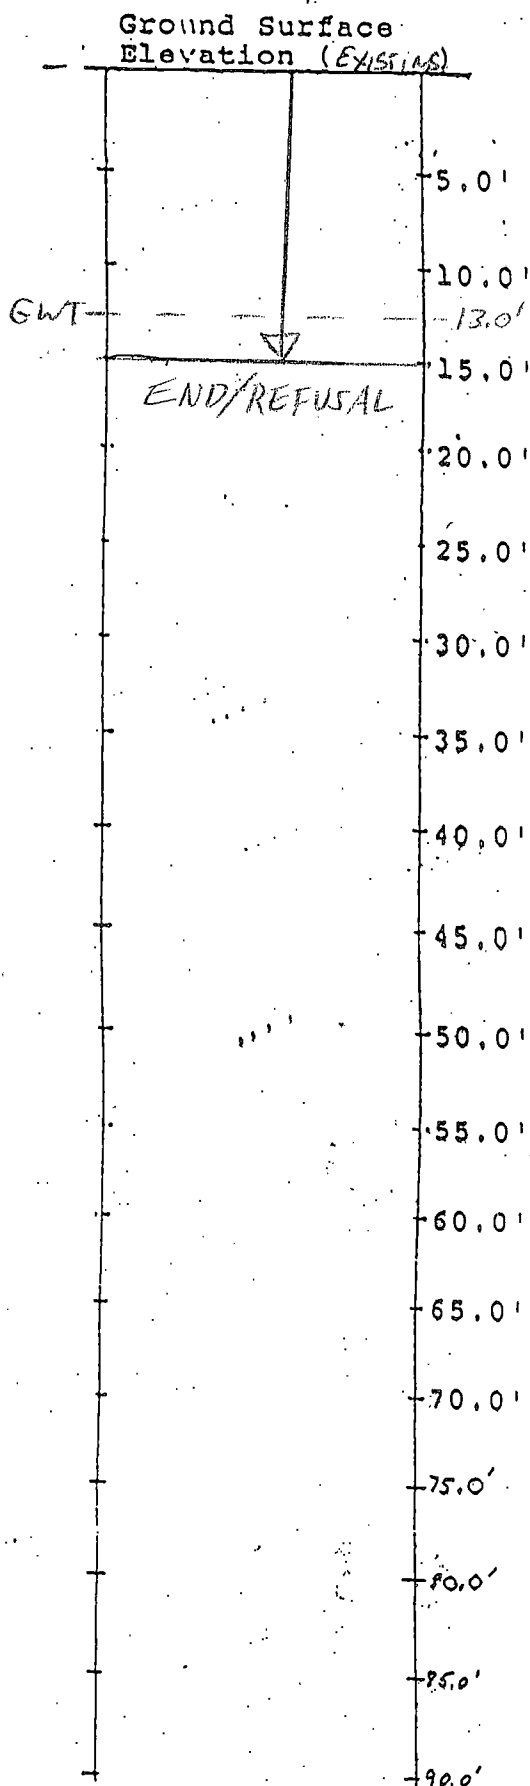
TEST HOLE # 3

Test Hole 6"Ø Dug to a Depth of  
15 feet. Hole filled with WATER  
RS/6, P113

Ground Water Encountered @ 13 FT.

System Saturated with Water. Steady  
Percolation Rate Achieved After  
Saturation is: 1.75 Gallons per min.

6"Ø TEST HOLE FILLED  
WITH WATER  
COMPLIED WITH RS/6, P113
