**125<sup>TH</sup> STREET FIREHOUSE RESTORATION  
NEW YORK, NY**

**GEOTECHNICAL INVESTIGATION  
REPORT**

**MAY 2011**

**HALCROW, INC.**

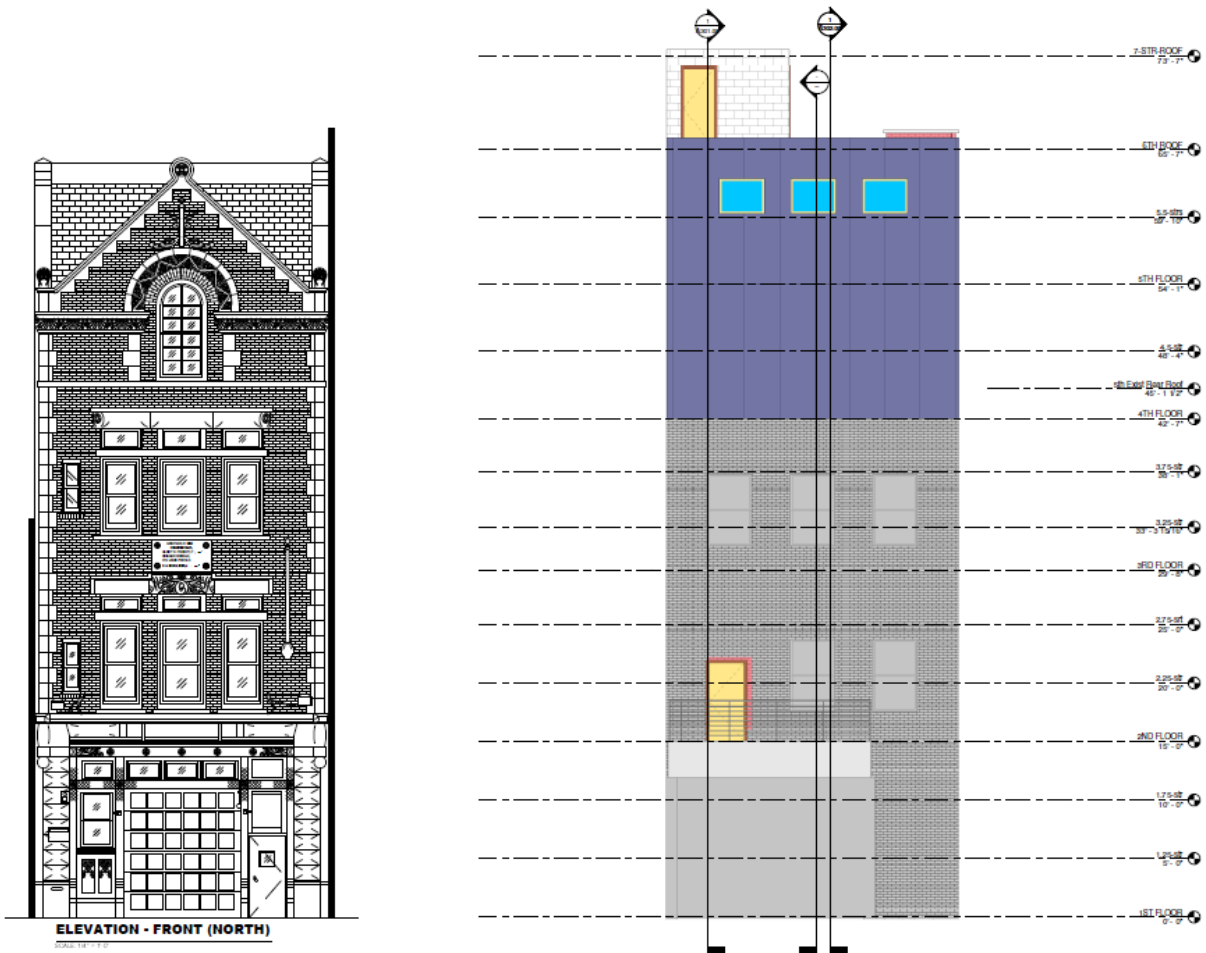
**Figure 3-2 Proposed Structure Front and Rear Elevations**

The increase of the structure height, and construction of additional floors, will result in an increase of the pressure applied by the current shallow foundation system on the underlying soils. Assessment of the new structure will require determination if the current foundation system is adequate, or modification of the foundations, by increasing them, is necessary.

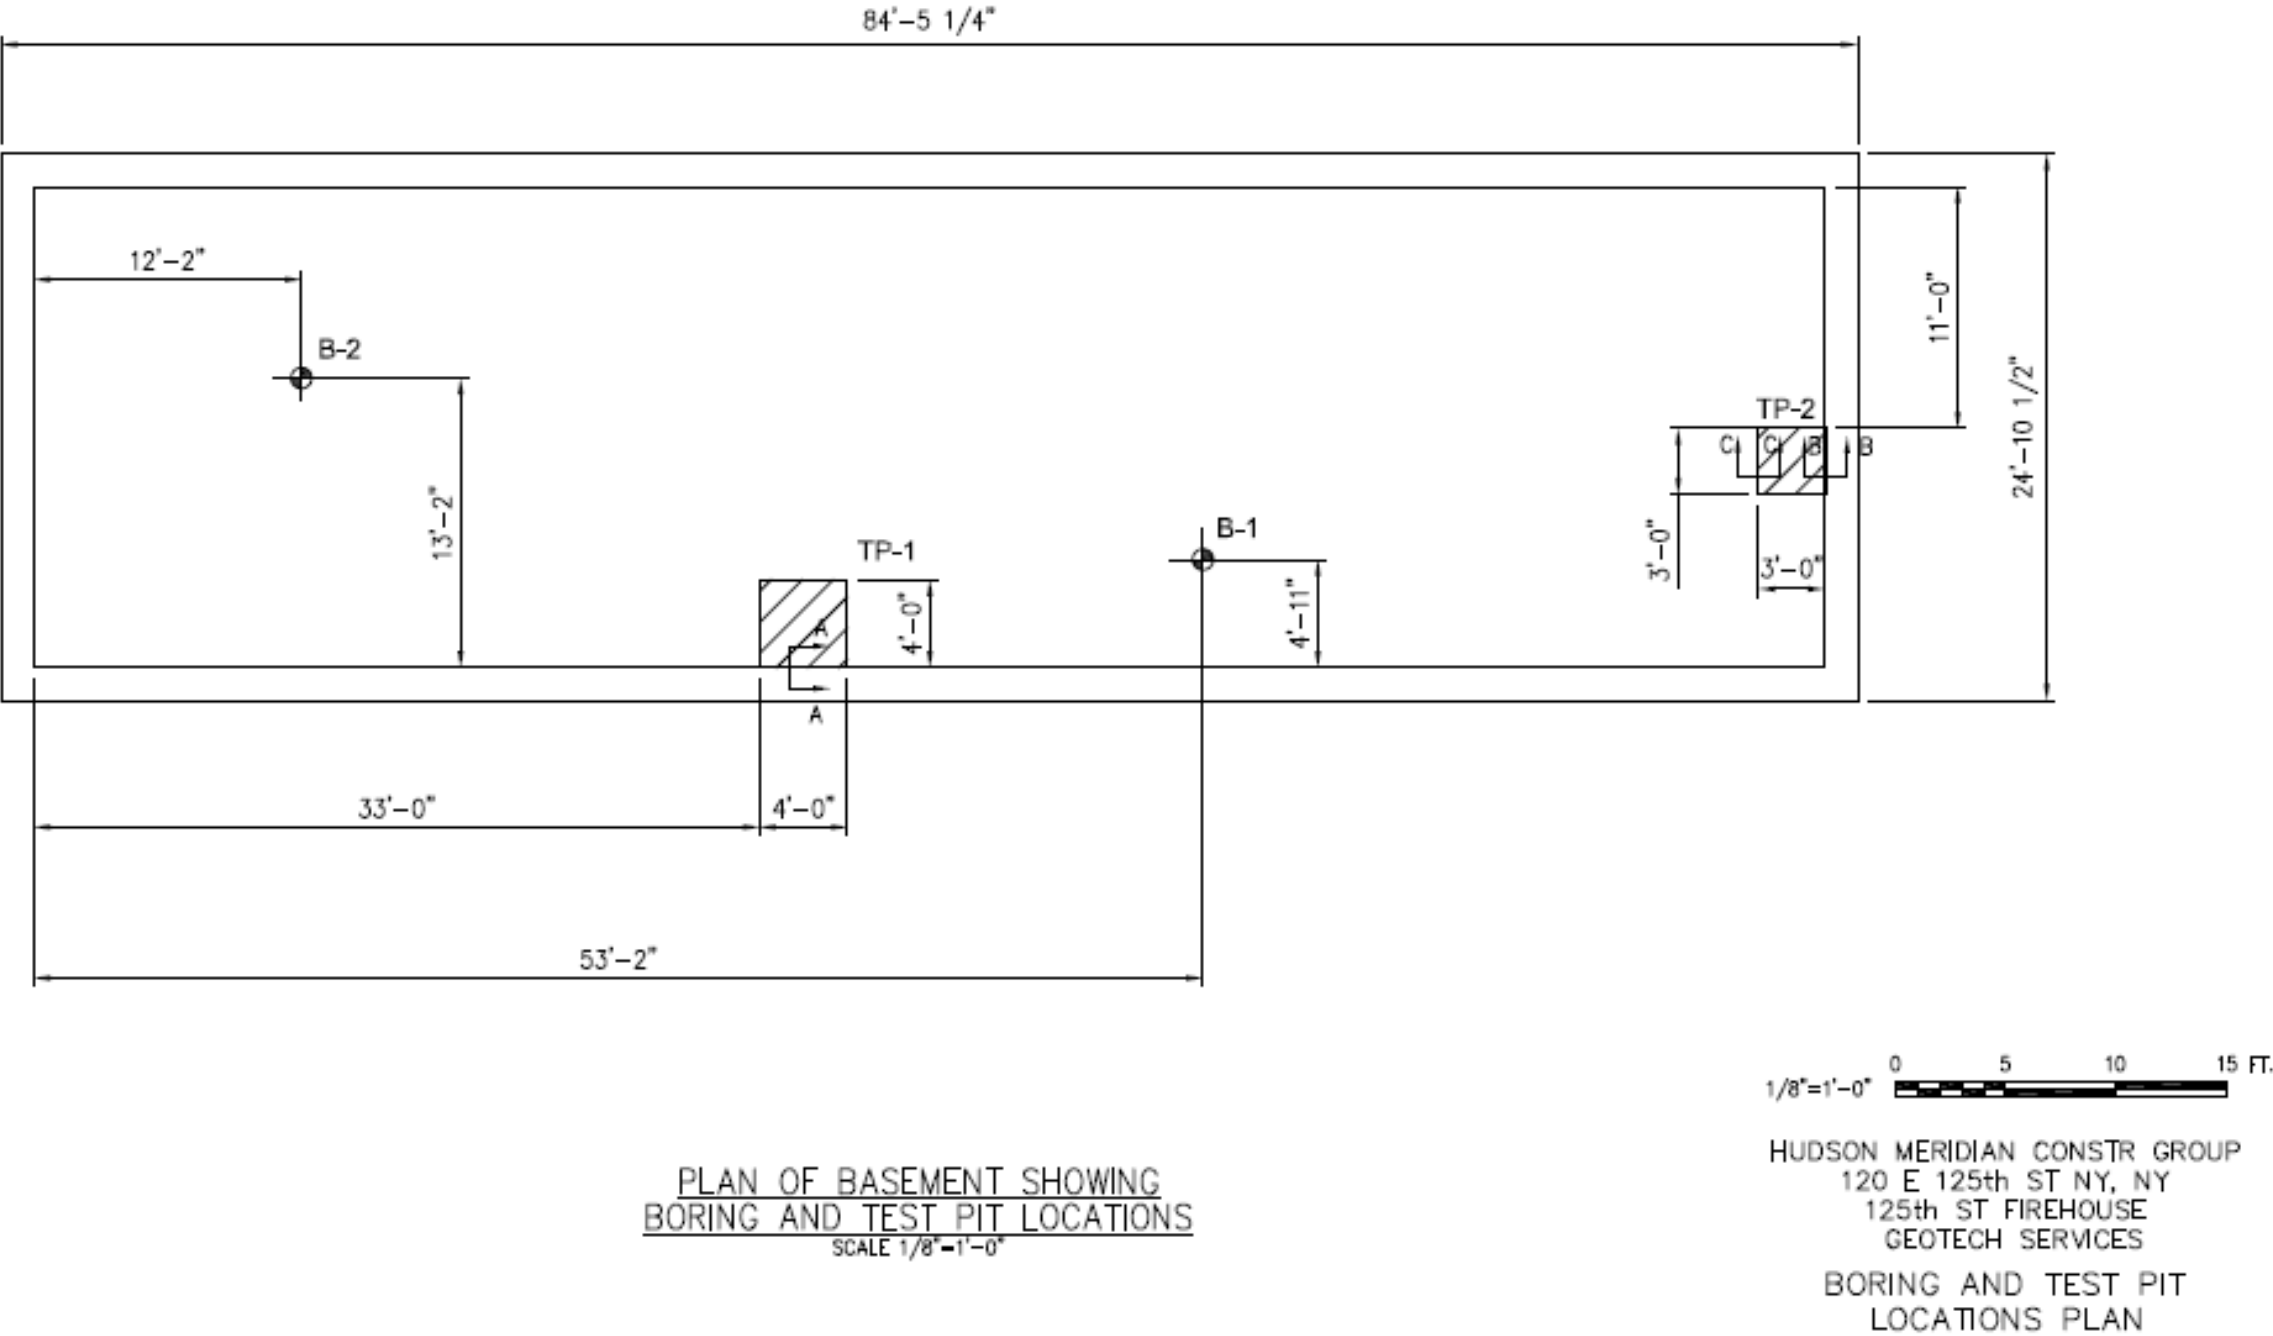
Figure 4-1 Boring and Test Pit Locations Plan

The field investigation included the advancement of two (2) test borings, and two (2) test pits for geotechnical purposes and to examine the existing building foundations. The two borings were advanced within the Firehouse structure, to depths ranging between 30 ft to 30 ft 11 in. beneath the basement floor slab; the borings extended through the overburden soils and into the underlying bedrock. Due to difficulties associated with limited access within the structure, the borings were advanced from the main floor slab (1<sup>st</sup> Floor Slab at El 0 ft) through the basement ceiling and then through the basement floor slab (El -9.48 ft) to the depths indicated above. Additionally, two test pits were conducted to depths ranging from 3 ft 8 in. to 4 ft 6 in. beneath the Firehouse basement floor slab (El -9.48 ft); these were conducted in order to examine the existing building's wall shallow foundations. As-built Boring and Test Pits Locations Plan is provided on Figure 4-1.

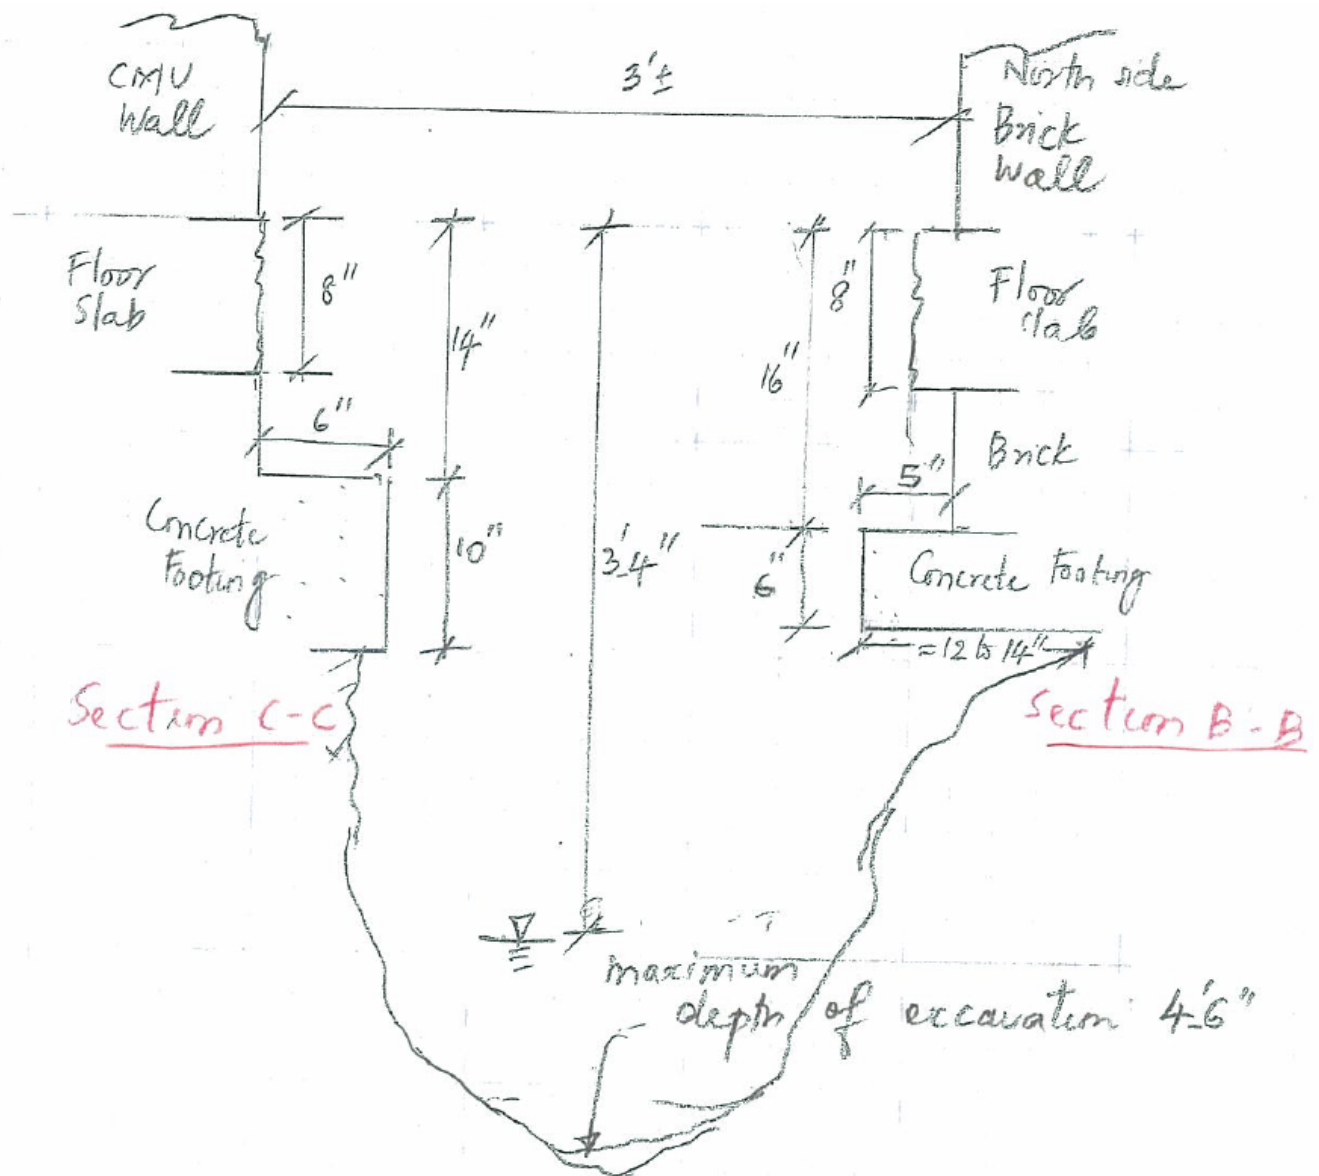
| D<br>E<br>P<br>T<br>H | SAMPLE<br>DEPTHS<br>FROM - TO | SAMPLE<br>TYPE &<br>NO. | STRATA<br>CHANGE<br>DEPTH<br>(ELEV.) | FIELD DESCRIPTION AND REMARKS |
|---|---|---|---|---|
| | | | 4 ft-6 in<br>(bot.) | <p>0 to 8": Basement floor slab consisting of unreinforced concrete</p> <p>8" to 4'-6": Brown medium to fine SAND, trace Silt (SP) with occasional gravel / cobbles</p> <p><b>Remarks</b></p> <p>The test pit was excavated to expose the existing foundation supporting the brick and CMU walls located in the vicinity of the test pit. Two concrete strip footings were revealed during this excavation. The excavation was terminated at a depth of 4'-6". Groundwater was encountered at about 3'-4" depth. The particulars are as follows:</p> <p>(1) <u>Concrete footing supporting the brick wall at the north end of the basement</u></p> <p>The top of this footing was found at the north face of the test pit at a depth of 16 in below the top of the floor. This footing which is about 6 in thick projects about 5 in from the face of the wall. This footing was locally undermined over a length of 2 ft (approx) run of the wall by as much as 12 to 14 in laterally under the footing. The width of the footing however could not be confirmed. No other supporting foundation element below the described footing was discovered. Section B-B in the attached sketch depicts the findings above.</p> <p>(2) <u>Concrete footing spanning the 3 ft gap between the CMU wall and the brick wall</u></p> <p>The top of a 10 in thick concrete strip footing that projects 6 in from the face of the wall was encountered at a depth of 14 in below the top of basement floor. This footing was not undermined and its width is not known. Section C-C in the attached sketch depicts the findings above.</p> <p>The test pit was backfilled and compacted with a hand-held square plate tamper upon completion of the investigations on 2/25/2011. The floor slab was restored on 2/28/2011.</p> <p>Picture 2 shows a view of TP-2</p> |

Concrete strip footing 12 in thick with its base at a depth of 2 ft below the top of the basement floor. The footing projects 12 in from the face of the brick wall above.
