## Soil Percolation Test

# DRYWELL PERCOLATION TEST

Drywell Percolation Test per Local law 103/89 & RS-16.

LOCATION: Moreland St.

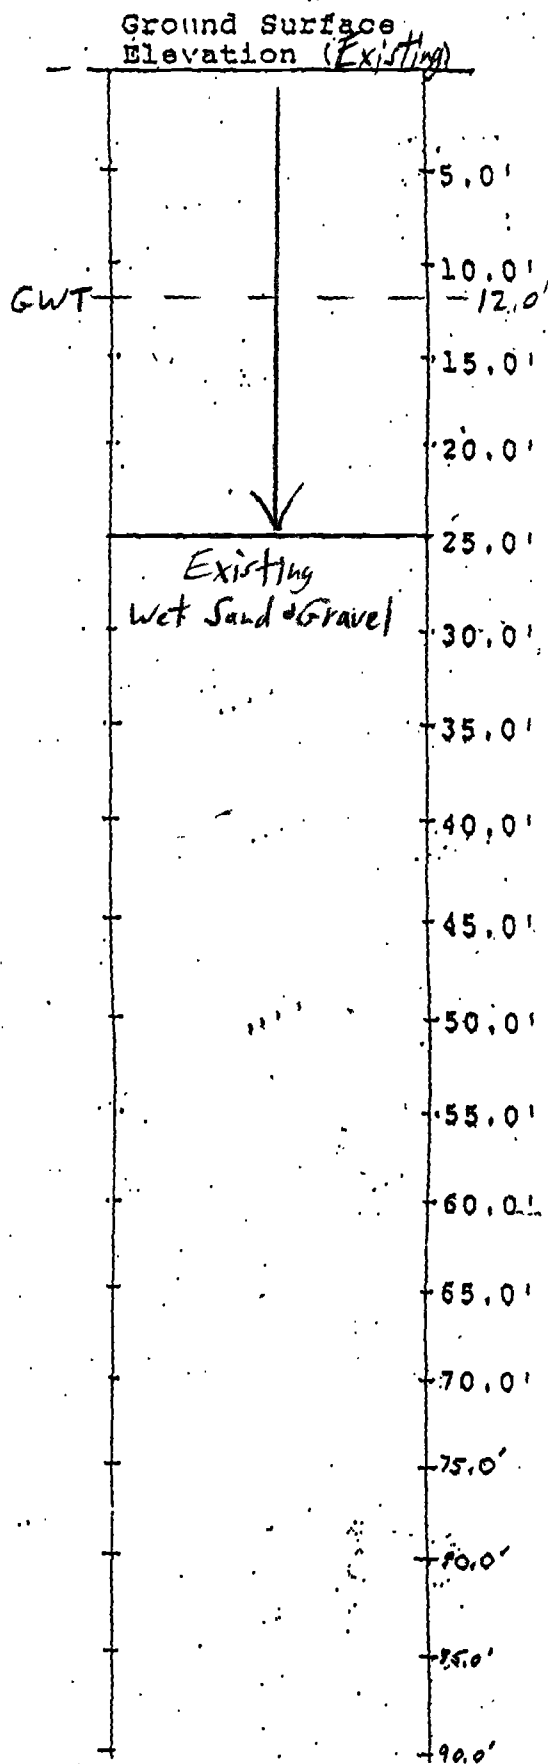
TEST HOLE 1

6" Ø TEST HOLE FILLED

WITH WATER

Test Hole 6" Ø Dug to a Depth of 23 feet. Hole filled with WATER  
RS16, P113

Ground Water Encountered @ 12'

System Saturated with Water. Steady Percolation Rate Achieved After Saturation is: 3.10 Gallons per min.

Section Through Test Hole Vertical  
Scale: 1" = 10.00'
