# BEDFORD AVENUE

PLAN SHOWING LOCATION  
OF SOIL PERCOLATION  
TESTS

# DRYWELL PERCOLATION TEST

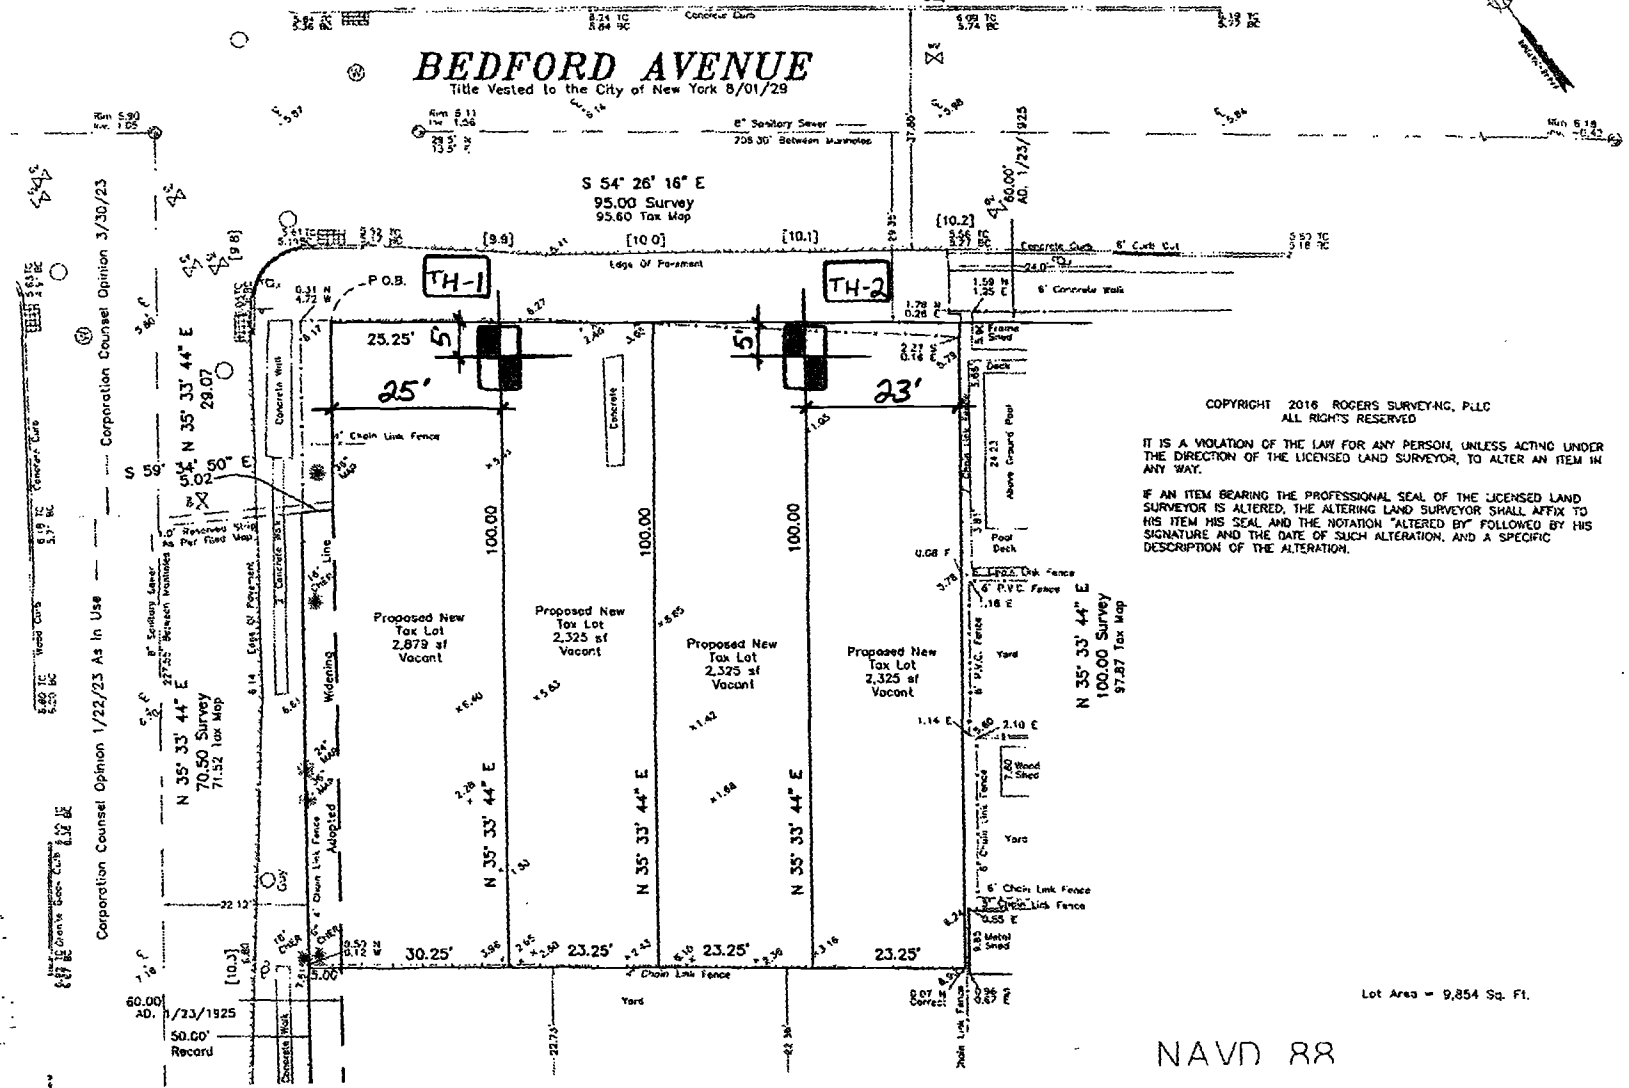
Drawing # 1 of 3

Lot Area = 9,854 Sq. Ft.

SCALE: 1" = 30' - 0"

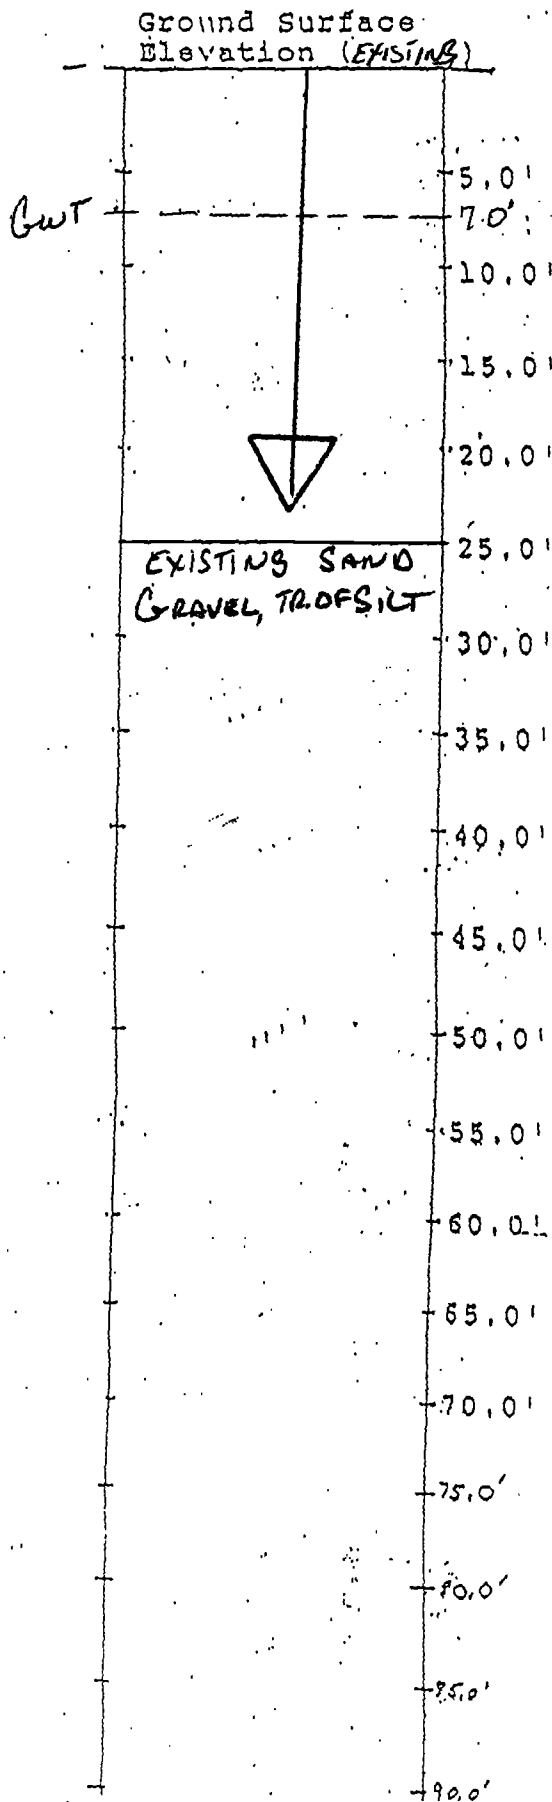
DRAWING # 2 OF 3 DRAWINGS

Test Hole 6"Ø Dug to a Depth of  
25 feet. Hole filled with WATER  
RS/6, P113

Ground Water Encountered @ 7 FT.

System Saturated with Water. Steady  
Percolation Rate Achieved After  
Saturation is: 3.05 Gallons per min.

Section Through Test Hole Vertical  
Scale: 1" = 10.00'

TEST HOLE # 1

6"Ø TEST HOLE FILLED

WITH WATER

COMPLIED WITH RS/6, P113

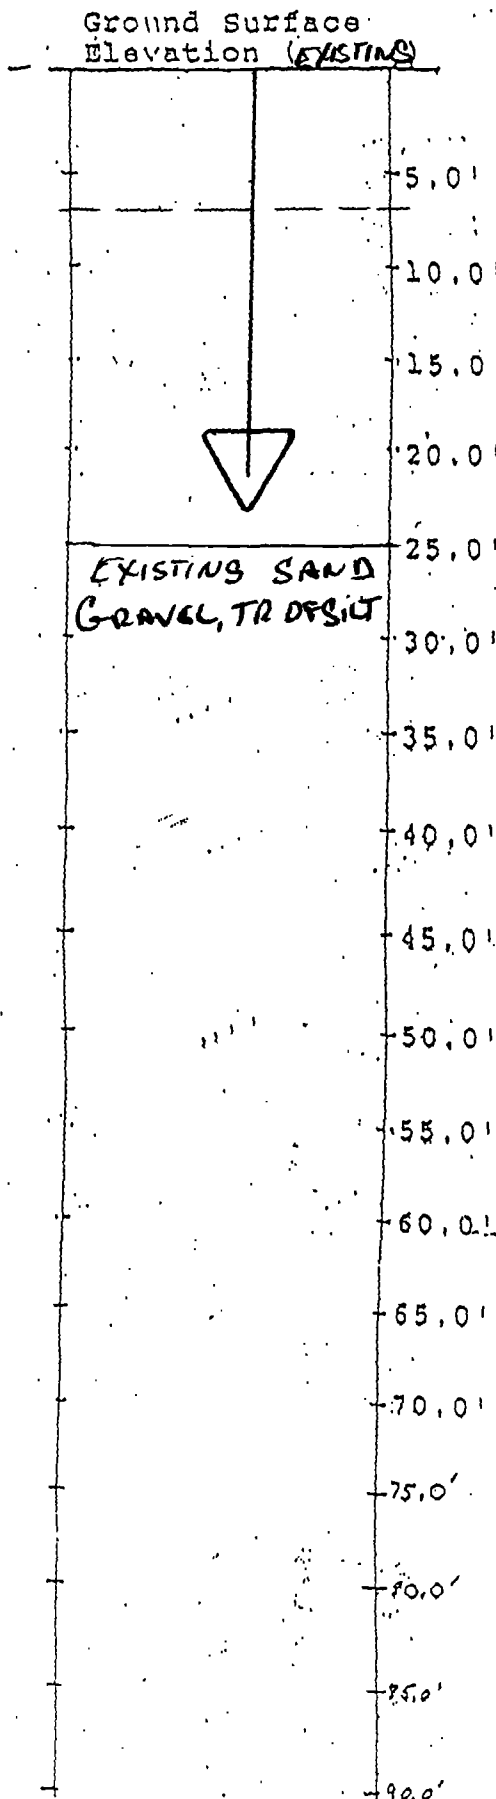
DRAWING # 3 of 3 DRAWINGS

Test Hole 6"Ø Dug to a Depth of 25 feet. Hole filled with WATER  
RS/6, P113

Ground Water Encountered @ 7 FT.

System Saturated with Water. Steady Percolation Rate Achieved After Saturation is: 3.00 Gallons per min.

Section Through Test Hole Vertical Scale: 1" = 10.00'

TEST HOLE # 2

6"Ø TEST HOLE FILLED

WITH WATER

COMPLIED WITH RS/6, P113
